Re: Contract N62470-89-D-4814
CTO-0106
Trip Report for MCB Camp Lejeune Project Plans
Site Visit

**TRIP REPORT
MCB CAMP LEJEUNE
CTO-0106**

On June 16, 1992, a site visit was conducted at MCB Camp Lejeune (specifically Sites 2, 21, 24, 74 and 78) by a Baker Environmental, Inc. project team. Team members included Matt Bartman, Coreen Casadei, Tammi Halapin, Joy Marshall, Mike Nutting, and Don Shields. The purpose of the visit was to give each of the team members an opportunity to visually inspect each of the five sites. Therefore, information necessary for scoping the work activities associated with the RI/FS project plans for the sites could be obtained.

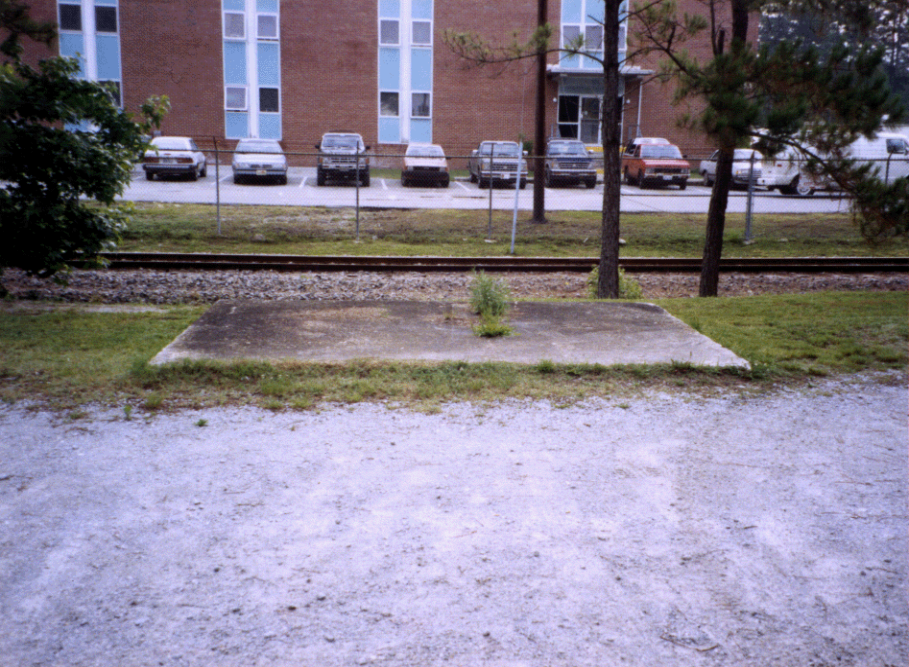
#1

MIXING PAD WITH
WATER TREATMENT PLANT
IN BACKGROUND

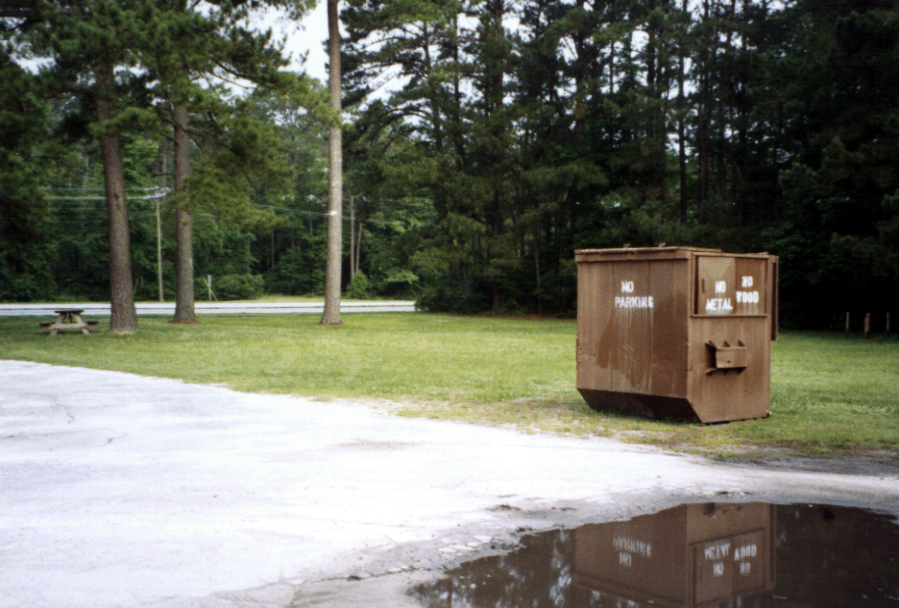
#2

SIDE LOT,
HOLCOMB BLVD IN BACKGROUND

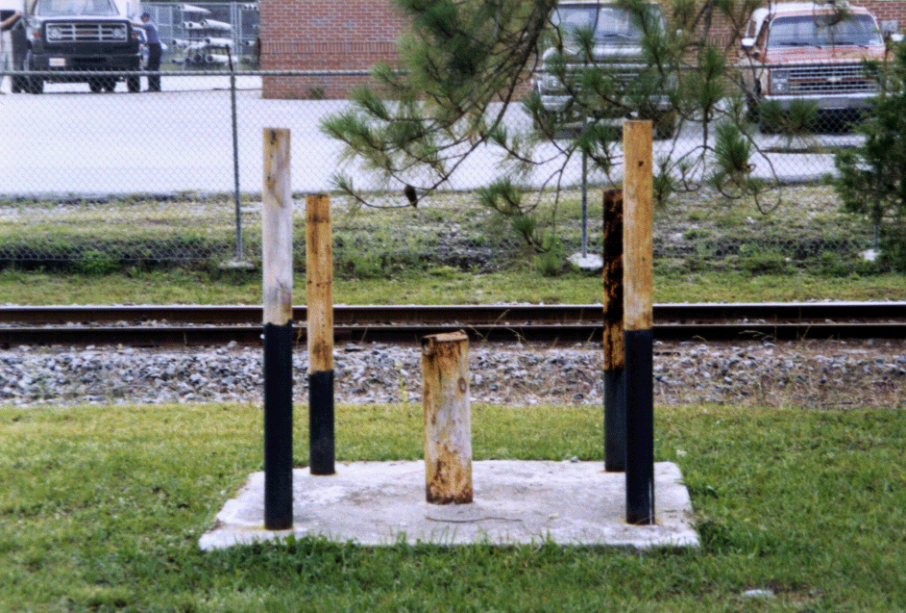
3

MONITORING WELL ZGW-1

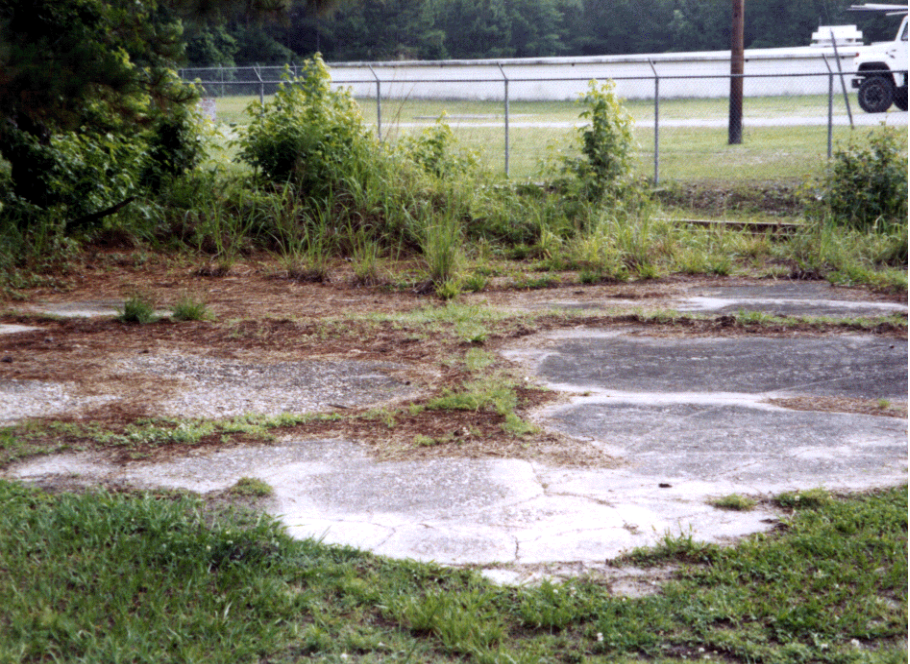
#4

WASH PAD;

RR TRACKS BEHIND

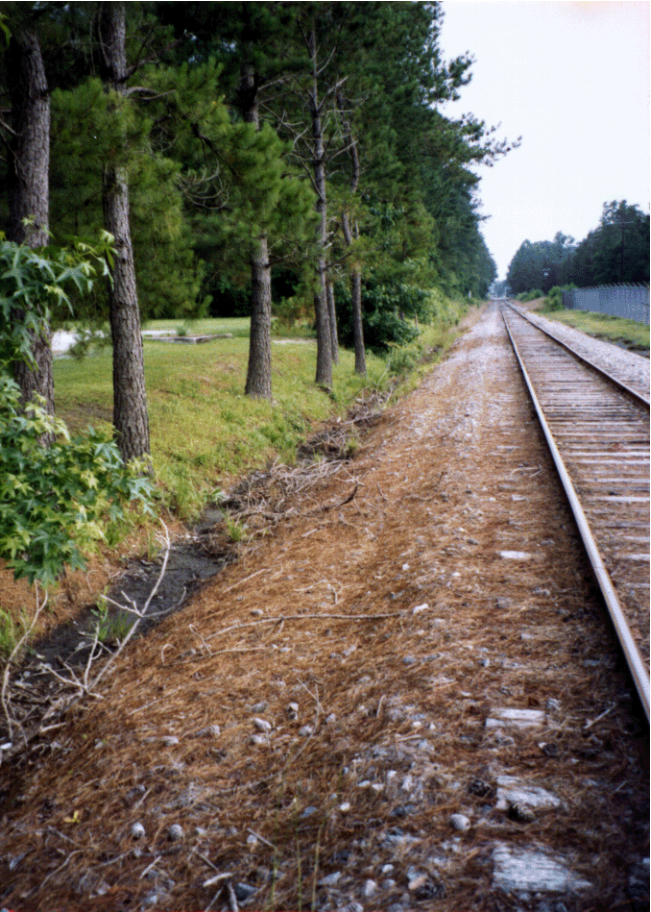
#6

DRAINAGE DITCH (FACING NORTH)

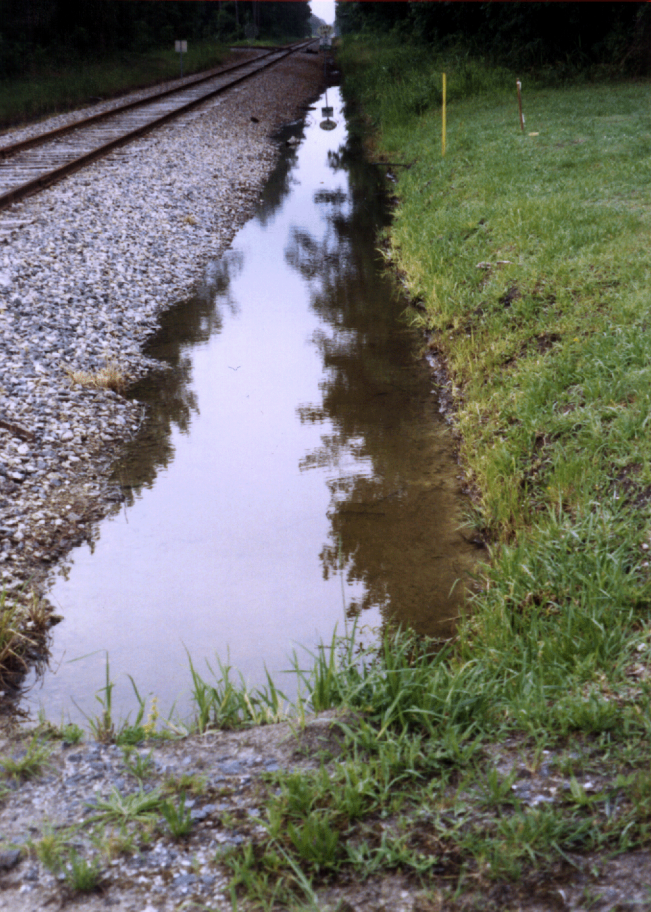
11

DRAINAGE DITCH;
FACING SOUTH

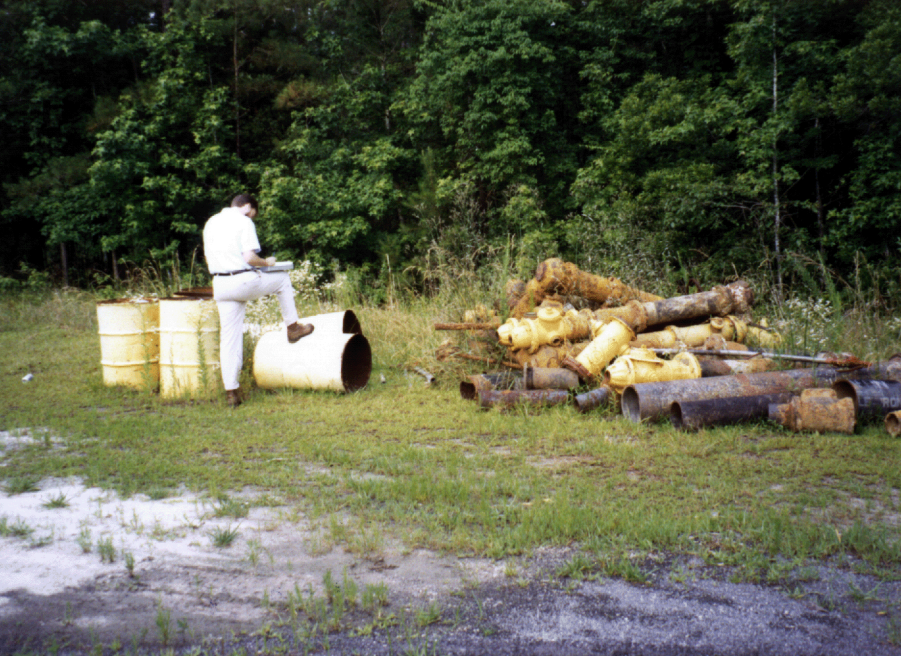
#7

STORAGE AREA (DON SHIELDS)

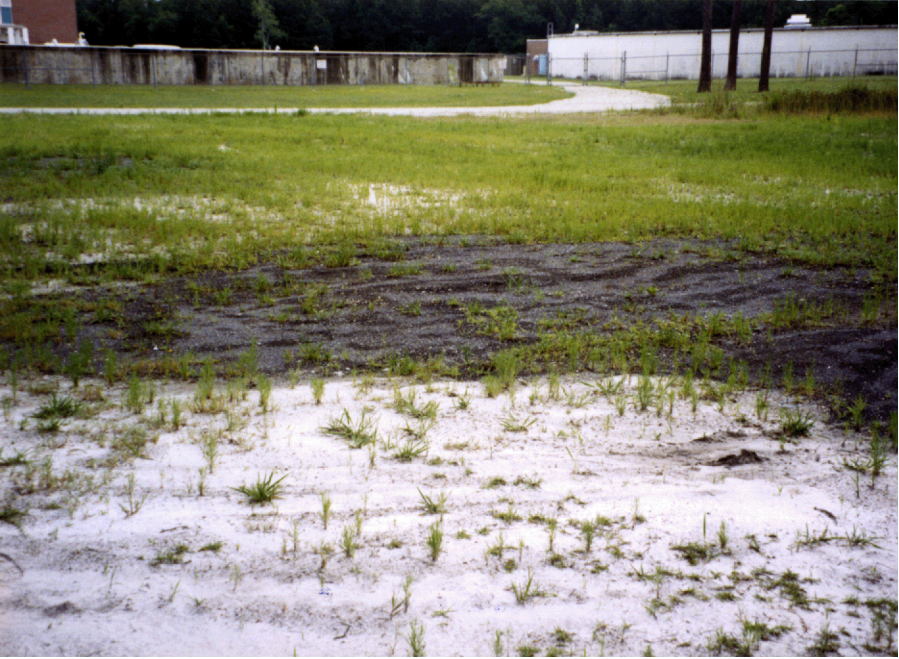
#18

ASHALPT W/IN STORAGE
AREA,

BACKGROUND - TREATMENT
PLANT (WATER)

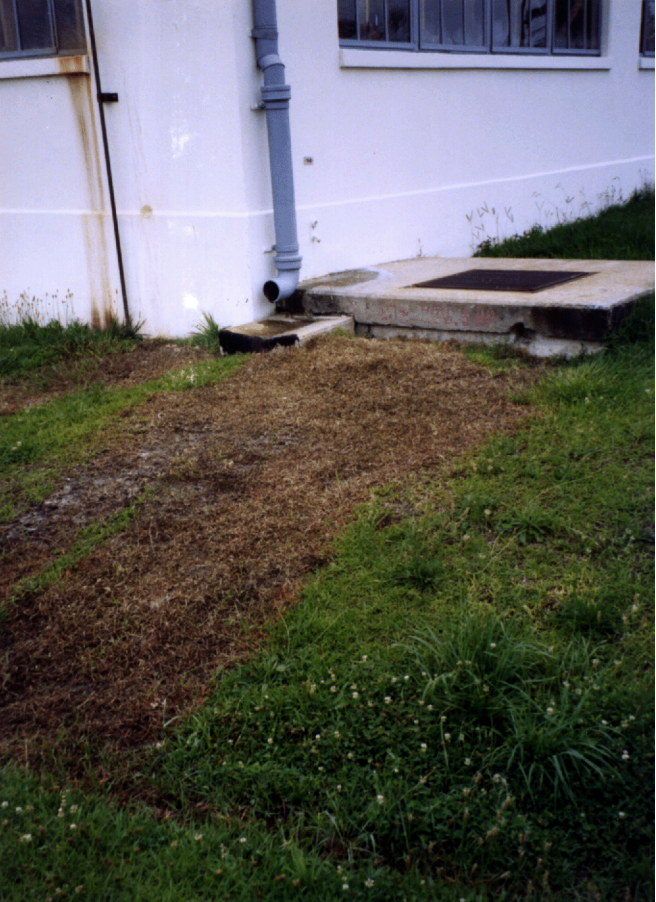
7

The next stop (approximately 8:15 am) was the Hadnot Point Industrial Area (HPIA). We visually inspected the exterior of Buildings 1202, 1300, 1107, and 1100. These buildings may have underground storage tanks located nearby. Photographs #9 through #11 were taken of Building 1202 - the photos were of: the stressed vegetation near the corner of the building; the area where a suspected UST may be or formerly may have been (no visible evidence); and the kerosene drums within this area.

STRESSED VEGETATION -
AT CORNER OF BLDG

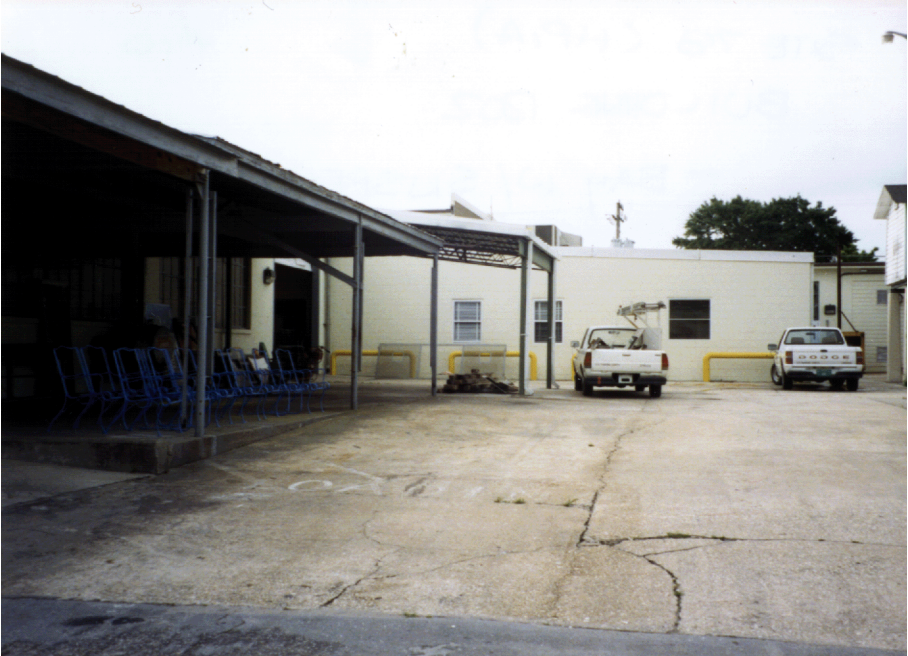
#10

- Bay w/ SUSPECTED CST

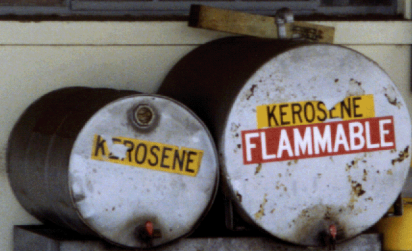
11

KEROSENE DRUMS IN
BAY AREA

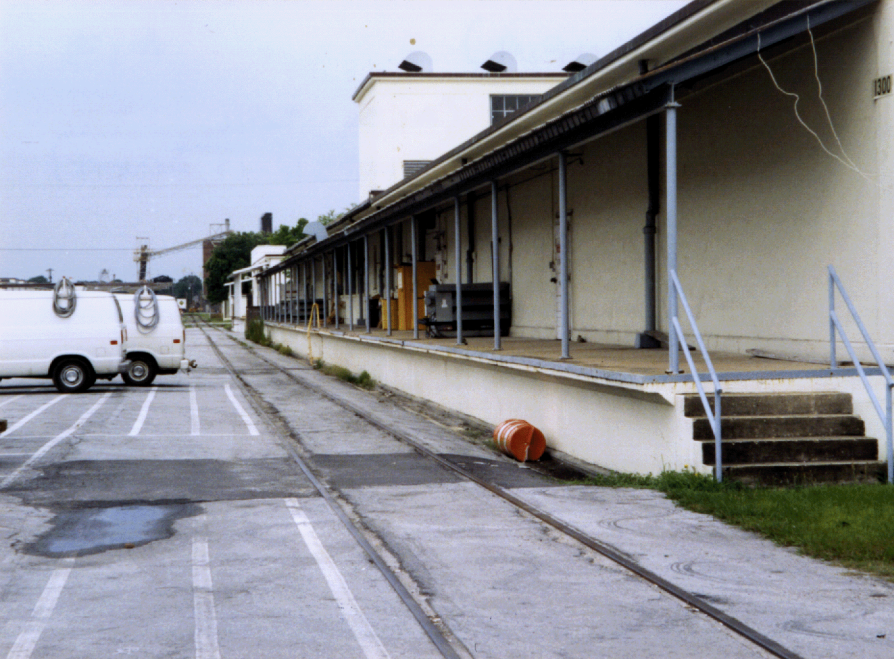
#13

BLDG 1300 (ALSO SOIL

SAMPLE HPSB-11 AREA)

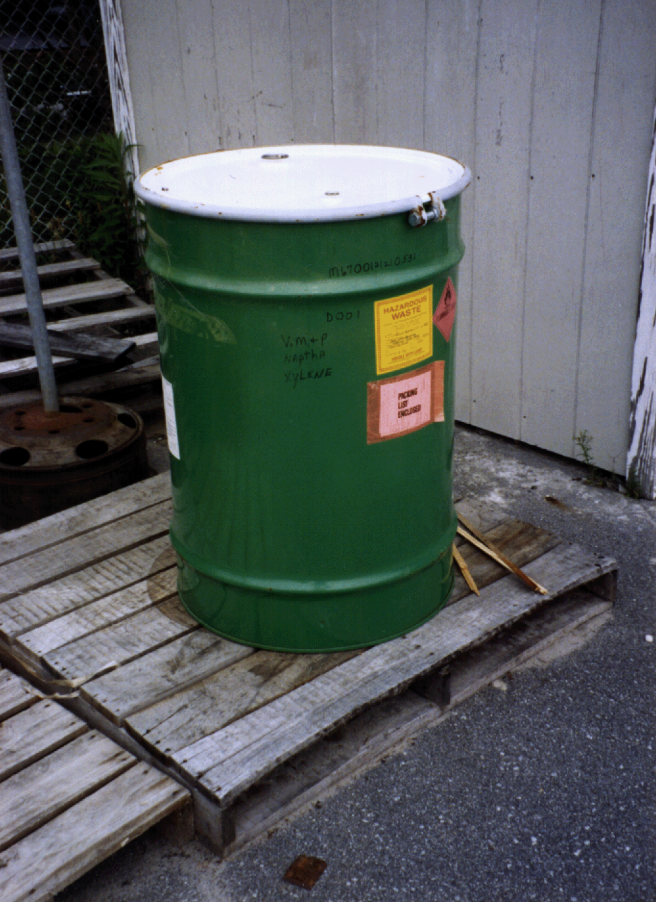
#14

At Building 1102, a photograph of a drum labeled as hazardous waste within an uncontained drum storage area located between Buildings 1102 and 1103 was taken. We were questioned at Building 1100 by Marine Corps Personnel. M. Bartman (Baker) talked to a Capt. McGrath on the phone in Building 1100 regarding our visit. Capt. McGrath said that in the future he would appreciate a courtesy call prior to our visits. Please note that the Baker team received permission from George Radford (Camp Lejeune Environmental Management Department) prior to conducting the site visit. Underground storage tanks are suspected at Building 1100. There are metal caps in the pavement surrounding the building (resembling tank filling/access covers) and what appeared to be 4 pipe vents running up the side of Building 1100. Drums of ethylene glycol are currently being stored between Buildings 1111 and 1100. The drums are surrounded by a one foot high sand bag barrier. Due to the attention and the questioning we received at this building, no photographs were taken.

(IN BETWEEN BLDGS 1102 & 1103)

- HAZ WASTE DRUM
W/IN STORAGE AREA

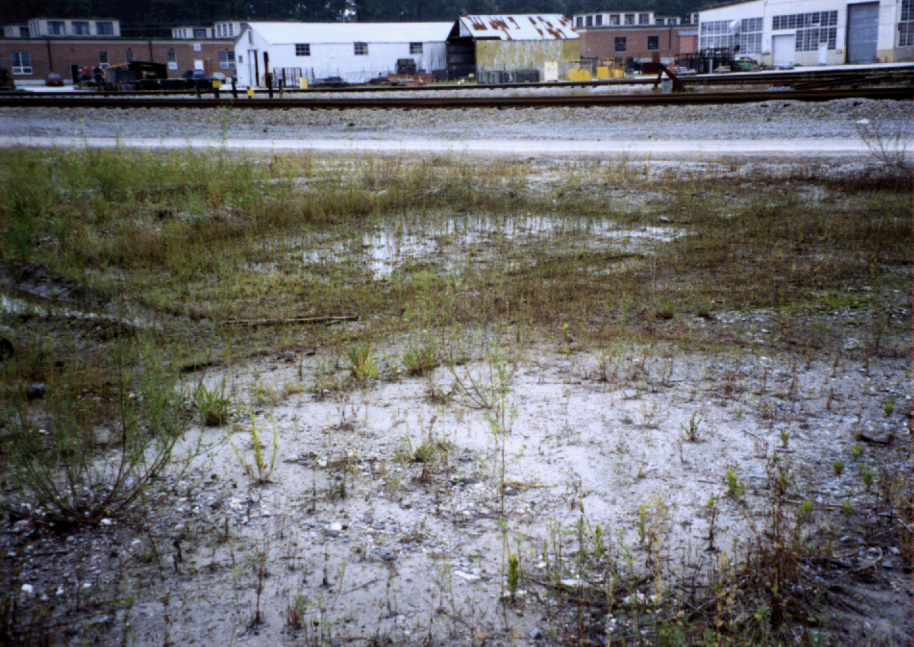
From HPIA we traveled to a more remote site, Site No. 21 (Storage Lot 140), where contact with military personnel would not be as frequent. The site is west of the fuel farm (Site 22). It is accessed by two dirt roads bordering both the east and west sides of the site which meet at the northern end. We potentially identified the former oil disposal pit area (Photographs #15 through #18). An oily, slimy looking residue was noted in this "pit" area. Fire ants were also noted.

PCB OIL PIT

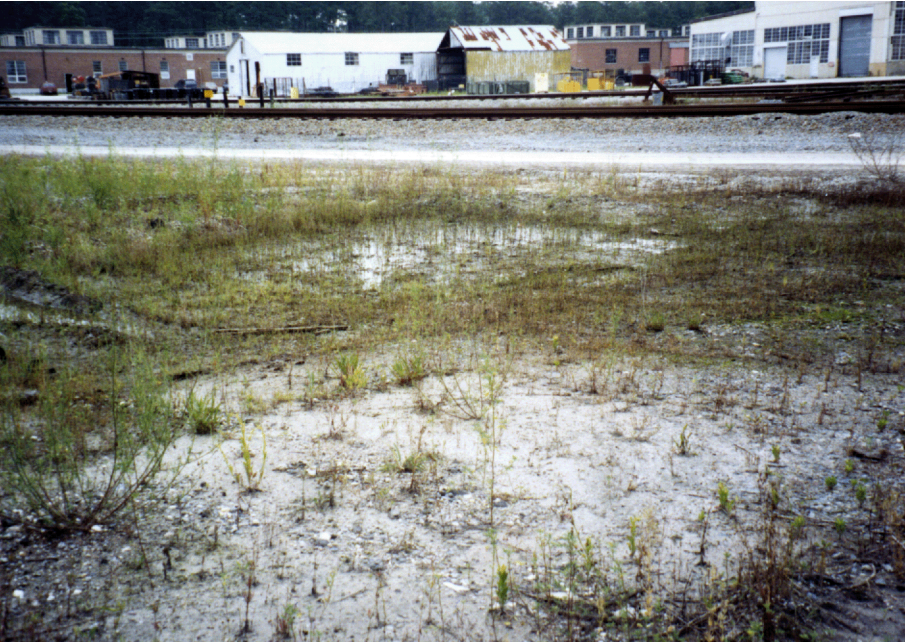
#16.

PCB CIL P17

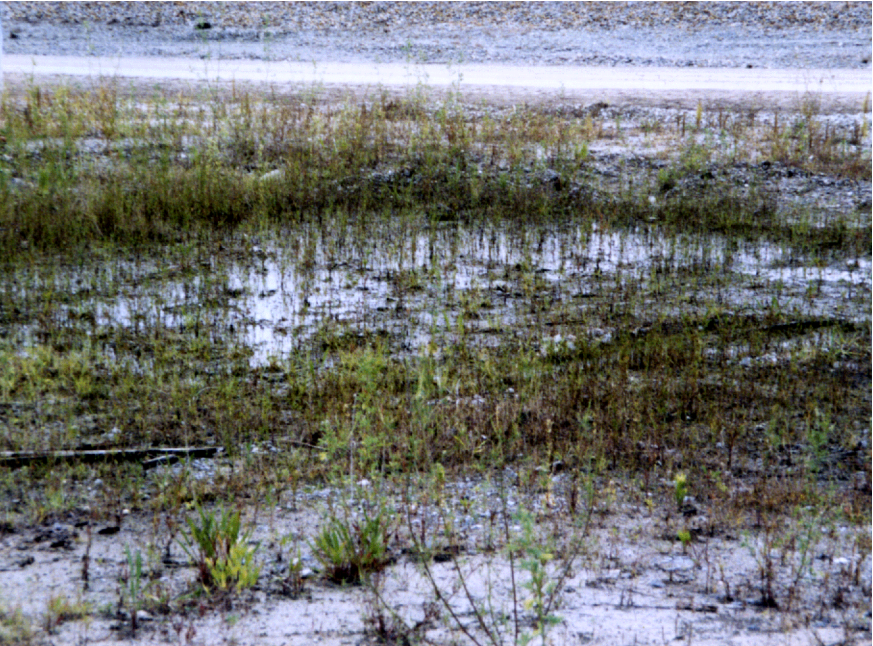
#17

PCB OIL PIT

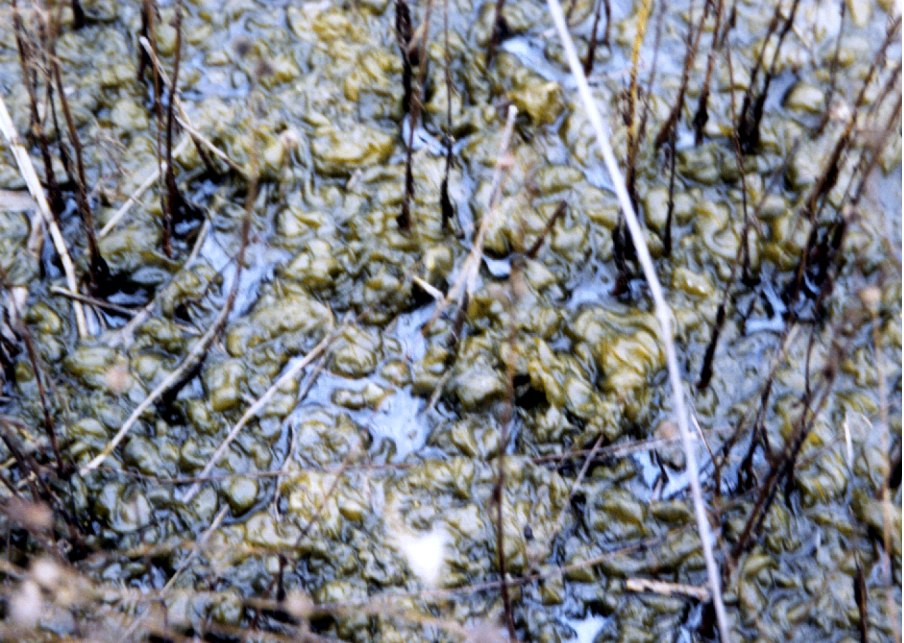
#12

-CLOSE UP -

OILY RESIDUE IN OIL PIT

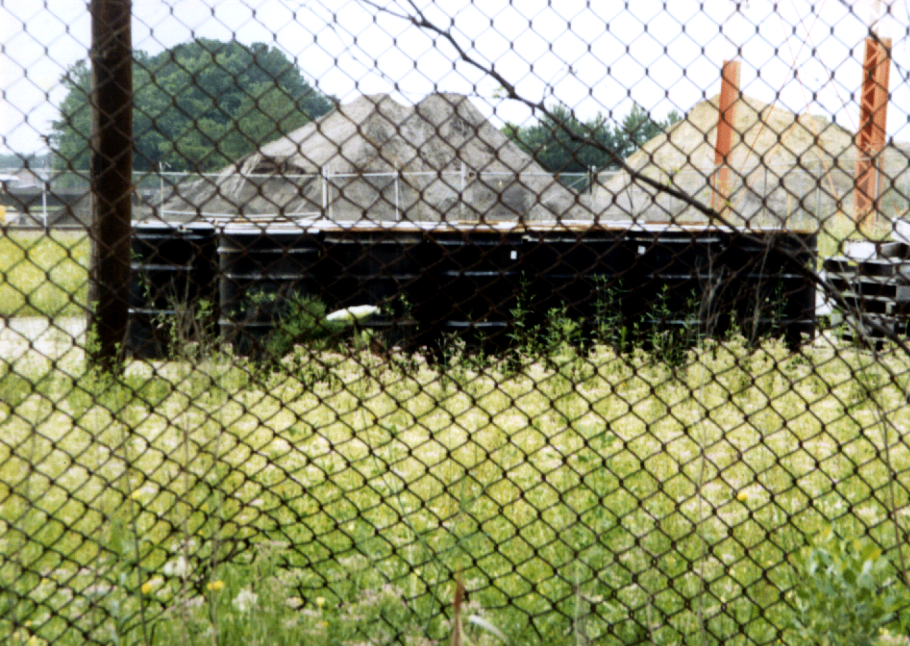
19

Within the fenced portion of Site 21, we noted that several drums stored on wooden pallets were ready to fall from their stacked position (Photographs #19 and #20). From a previous site visit, T. Halapin was informed that these drums contain soil cuttings from the base.

- DRUMS (SOIL CUTTINGS)
WITHIN LOT 140

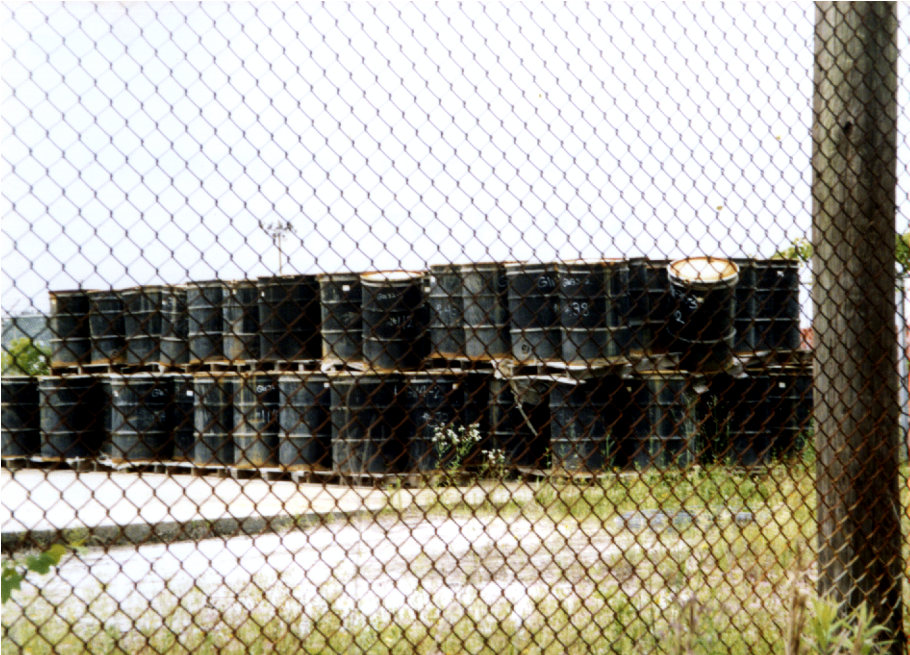
± 70

- DRUMS (SOIL CLTINGS)
W/IN LOT 140
(BROKEN PALLETS)

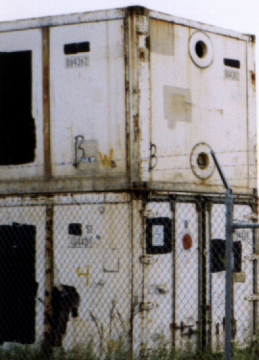
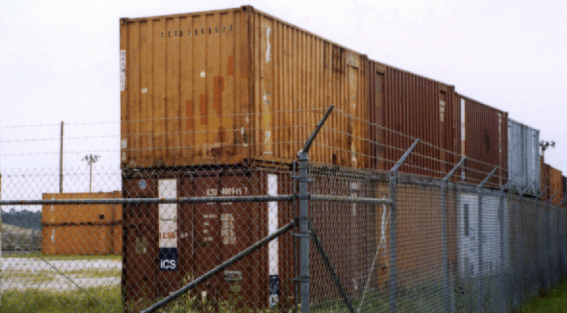
21

Two photographs (#21 and #22) were taken outside the fenced-in area at the southern end of Site 21. This is the area where pesticide mixing activities reportedly took place. Large refrigeration boxes are presently stored in this area. Note that large mounds of fire ants were noted in this area. A car wash facility is located directly west of this portion of the site.

- LOT 140,
SOUTHERN END

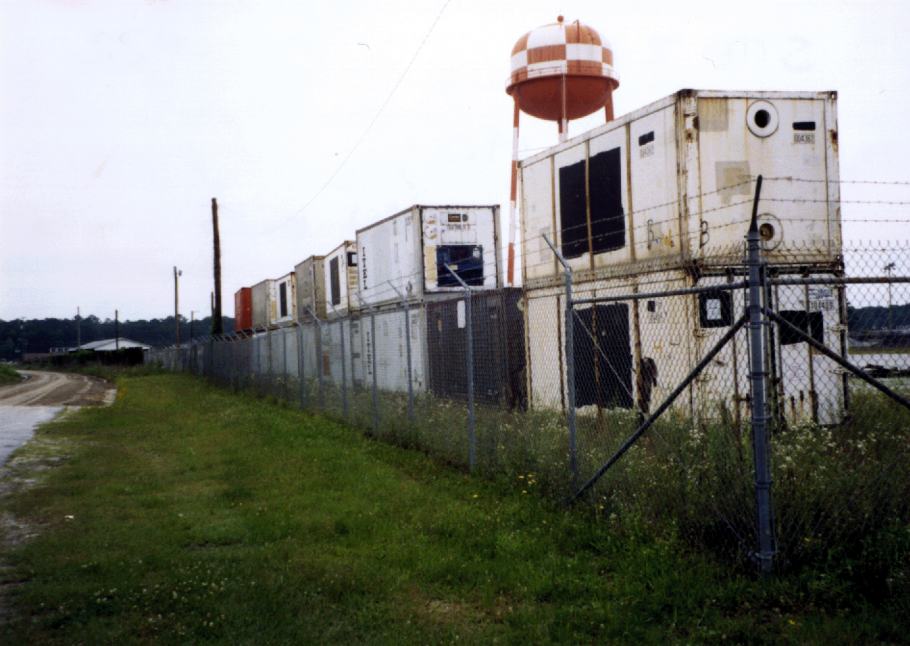
#22

- LOT 140;

SOUTHERN END

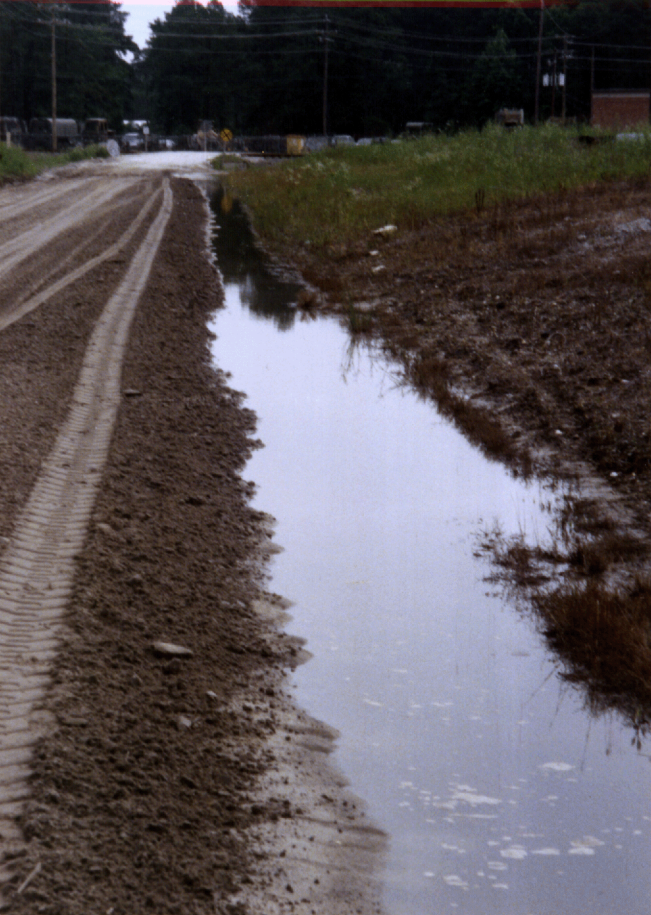
Site 21 had some orange leachate draining into the northeast side of the ditch bordering the north side of the site. This water-filled ditch had many tadpoles present. Photograph #23 was taken of the drainage ditch facing toward to the north - facing the 900 buildings.

- DRAINAGE DITCH -
(FACING NORTH)

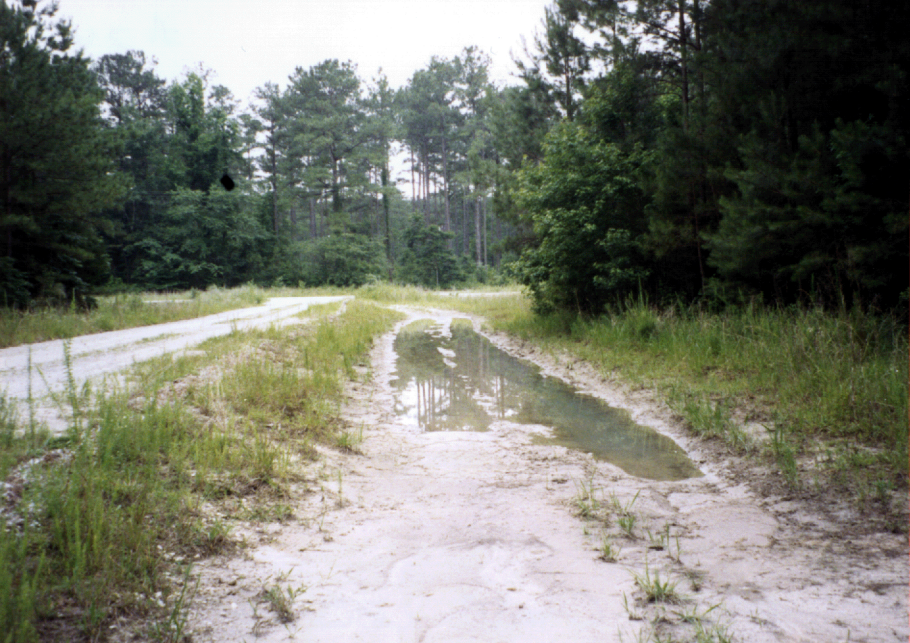
#24

- WATER FILLED PIT?
- (FACING MAIN ROAD)

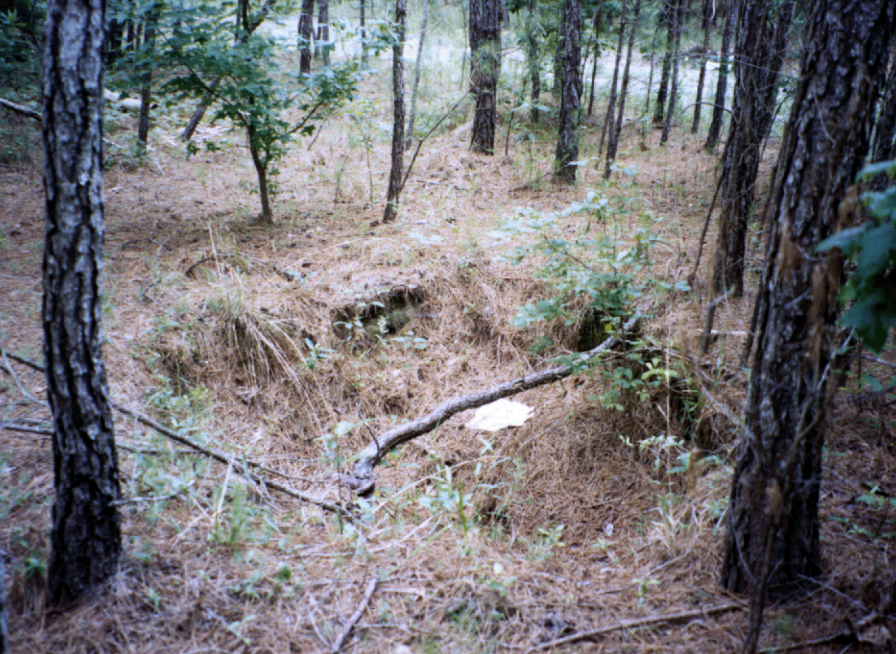
* 5

Debra left us around 3:30 pm after locating Site 74 with T. Halapin. Access to Site 74 from the main gate is the first left off of Holcomb Blvd., from Wallace Creek it is the third right off of Holcomb Blvd. Site 74 is relatively flat and heavily vegetated. We walked through the woods trying to find the existing wells. We found well 74GW1 adjacent and east of the dirt road that borders the 'suspected' former grease disposal trench (Photograph #24). Well 74GW2 was found adjacent and north of the access road from Holcomb Blvd. It is directly behind a utility pole marked with a sign that reads "RA". Both wells were marked with flagging tape. We were unable to locate well 74GW3. Subsidence holes were found west of the dirt road. The largest hole measured approximately 5' by 3' by 2.5' deep. This hole appeared to have a rusted, open drum laying on its side. We photographed the hole and continued our investigation (Photos #25 and #26). Other holes were found near the larger hole.

- SINK HOLE
(~ 4' x 6')

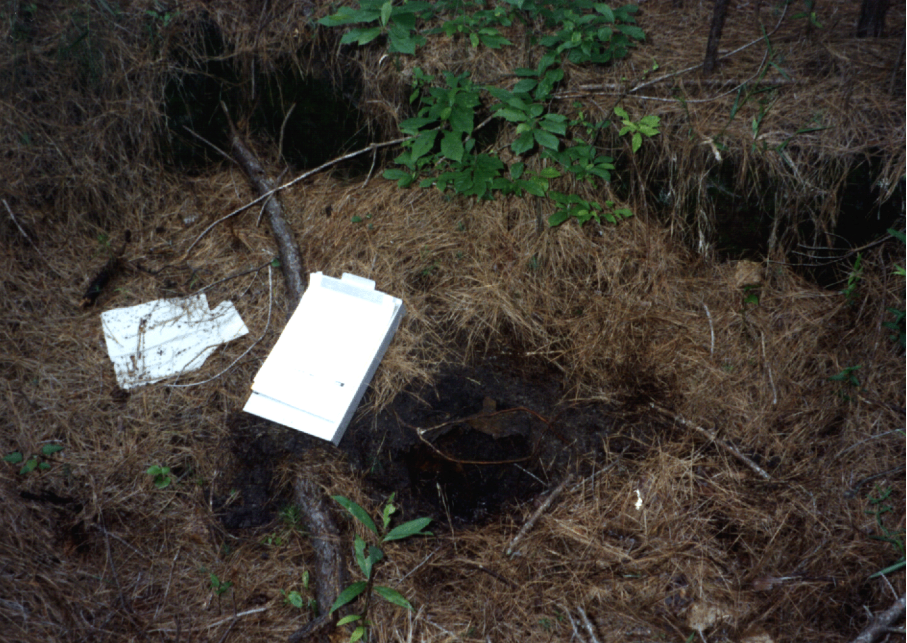
#26

RUSTED DRUM REMNANT
IN SINK HOLE

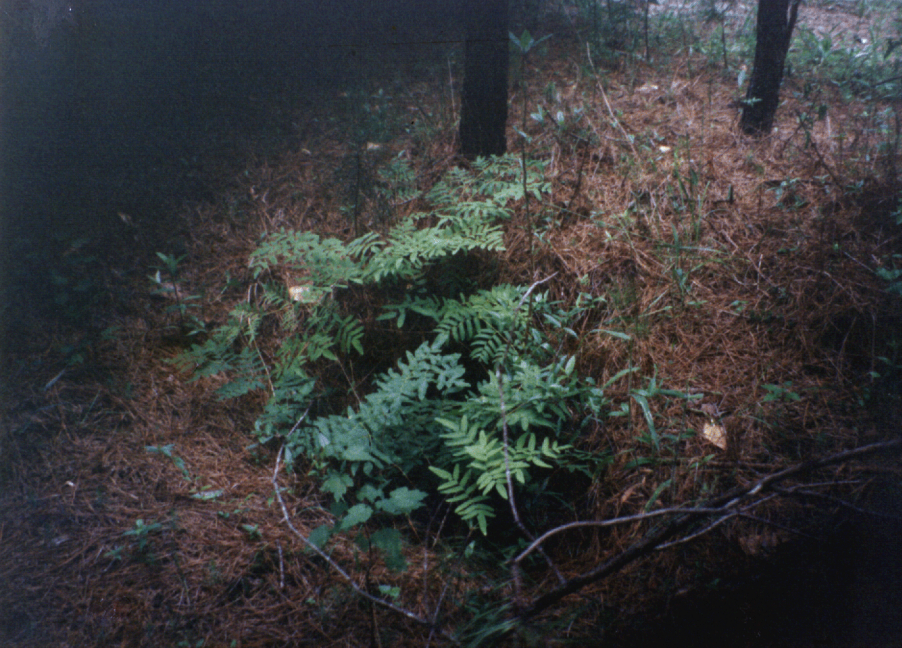
#27

One depression measured approximately 3' in diameter and was about 1.5' deep (Photo #27). Nothing unusual was observed in this hole. A few depressions were also found near the intersection of the access road and the dirt road. The dirt road contained large deep puddles that covered the width of the road. Another road not shown on our mapping broke off west of the dirt road, looped around the heavily puddled areas and reconnected with the dirt road. Both the dirt road and the road not shown on the mapping appear to be regularly traveled from the tire tracks on the road. Also, the site appears to be periodically populated by humans judging from some of the debris found at the site.

- SECOND (SMALLER)
SINK HOLE

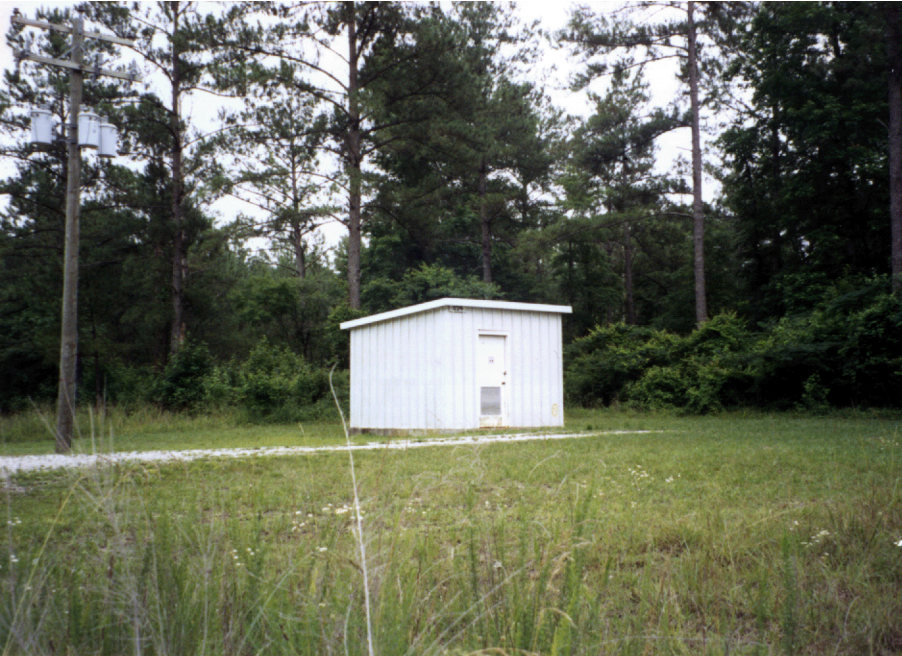
#29

The woods east of the dirt road contained trees that had utility line holders and empty switch boxes. Potable Public Supply Well 654 is located south of the access road. A motor was heard running from the well house (Photo #29) so we assumed that it was an operational well. The former pest control area had no obvious features that distinguished it as a hazardous area (Photo #30). Upon leaving the site we drove to Hendersen's pond, a public fishing area on the base, to measure how close it was to site 74. The pond is about 0.4 miles from site 74. In addition Site 74 was evaluated for the field geophysical survey that was to take place in the next few days.

PUMP BUILDING 654

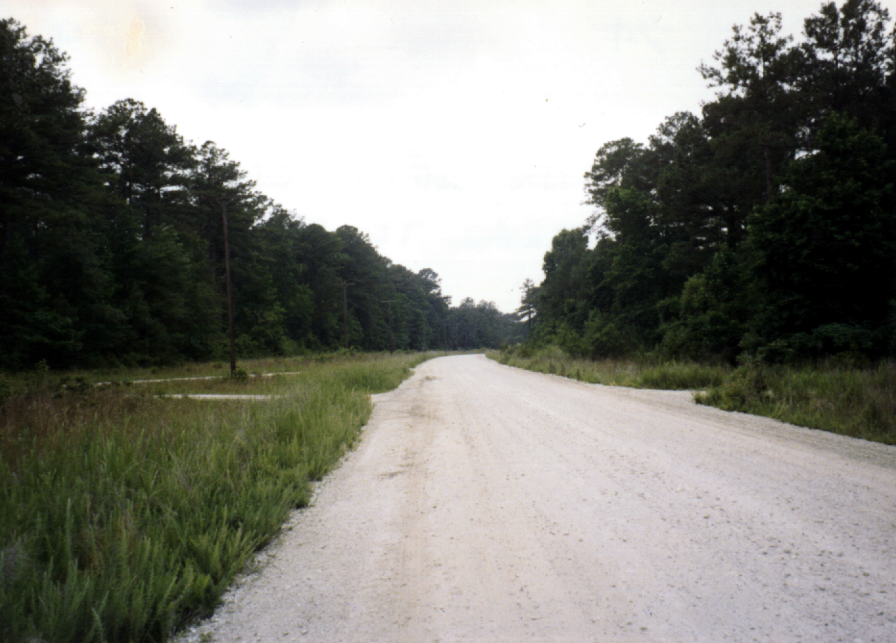
1,1

- PESTICIDE AREA CN. LEFT?
(NEAR TELEP POLE)
